UNDERWATER APPLICATIONS OF PREFABRICATED PLUGS USED FOR THE MAINTENANCE AND REPAIRS OF INTAKES AND WATER CONVEYANCE

Bruno Bagnères P.Eng., Sr. Civil Engineer and Associate, Klohn Crippen Berger (KCB) BC, Canada

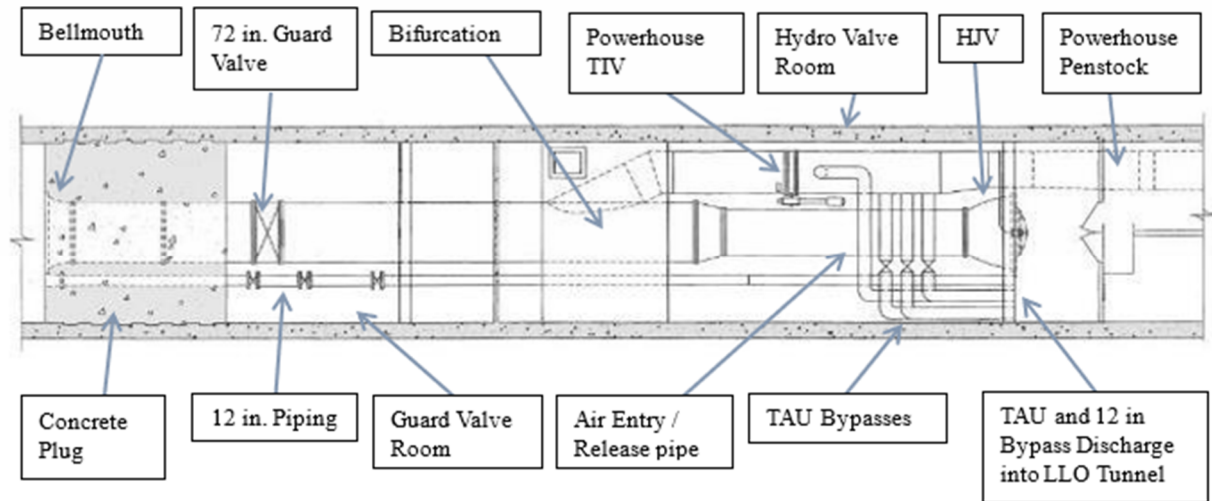
Figure 2-2: Plan of original LLO valves and conduits

Both the original 72 in. (1.8 m) guard valve and the HJV had reached the end of their service life and leaked heavily. Accessing either valve for maintenance was not possible due to this leakage. For dam safety and operational reasons, the valves in the LLO had to be replaced. There were no means to dewater the LLO without draining the reservoir and then pumping inflows into the canal or over the dam. Dewatering the reservoir would have significant financial and operational consequences to the users who rely on the water stored behind the dam. The tunnel upstream of the LLO plug was of unknown geotechnical stability, so installing a plug or barrier at the upstream end of the diversion tunnel was determined to be unfeasible. After an initial round of investigations, a decision was made to proceed with the installation of a plug at the upstream end of both conduits, passing through the LLO plug.

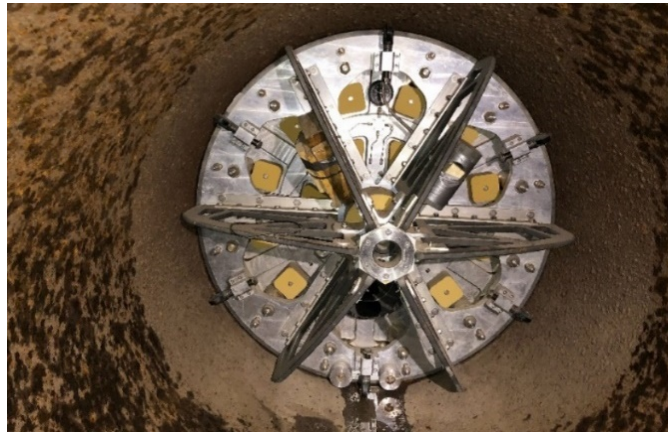
Figure 2-3: Installed 72-inch (1.8 m) isolation barrier, from downstream

The flow past the isolation barrier, with only the mechanical seal activated, was measured to be between 240 gpm (15 L/s) and 400 gpm (25 L/s). Following these measurements, the inflatable seal was actuated, and a 24-hour waiting period was observed. The leakage flow rate reduced significantly and was measured to be less than 0.03 gpm (2 mL/s), which satisfied the contractual minimum leakage flow rate of 16 gpm (1 L/s). Design criteria for the isolation barrier required that the primary seals not rely on a pressure source, either air or water. Once the mechanical seals had been confirmed to reduce the leakage to an amount that would not be a hazard to downstream workers, inflatable seals could be used to reduce the leakage further. The seals on the isolation barriers functioned extremely well, resulting in very minimal leakage for the duration of the isolation.

With the 72 in. guard valve closed, and the leakage rate measurement completed, work began to install the 72 in. (1.8 m) isolation barrier. The plug installation went reasonably smoothly. Two ROVs were used to transport the isolation barrier down the diversion tunnel, one upstream and the other on the downstream side. When the isolation barrier approached the LLO, the downstream ROV disconnected and moved out of the way. Shortly after the downstream ROV disconnected, a power failure on the barge caused the upstream ROV to disconnect from the isolation barrier. The isolation barrier floated free and came to rest on the silt at the bottom of the tunnel. When the power was brought back online, the crews managed to reconnect the ROV to the docking probe on the barrier. That same evening, the isolation barrier was inserted into the 72 in. (1.8 m) conduit. The mechanical seal was activated and the bypass valve through the isolation barrier was closed.

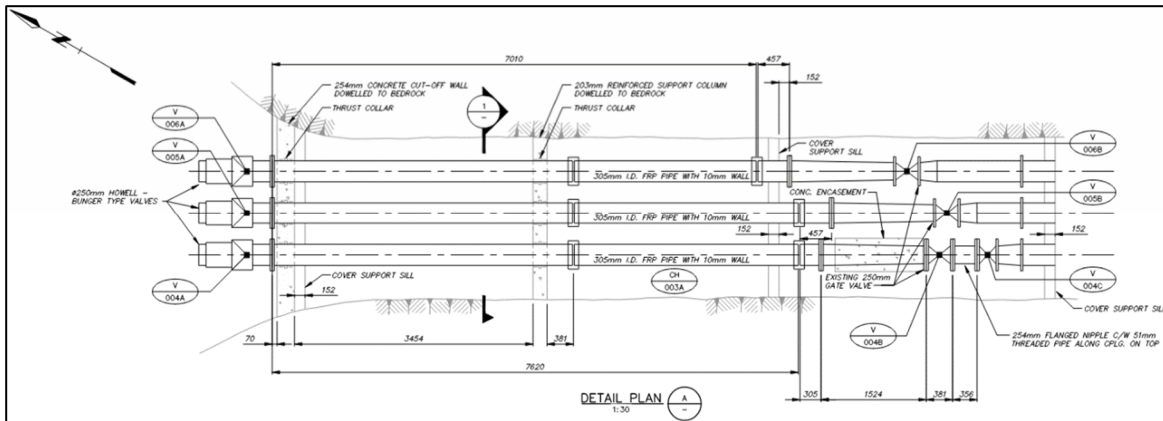
Figure 3-2: Palisade Lake west outlet plan view

During an assessment of the piping in 2017, piping between the bulkhead and the isolation valves was found to be seriously degraded. Initially, KCB was asked to look at options for replacing the entire outlet facility, but it became apparent that replacement of the facility was a longer-term solution and the condition of the pipes had to be dealt with in the shorter term.

KCB presented several options to Metro Vancouver, these included mechanical or inflatable plugs installed from downstream, pipe freezing techniques, a plug installed from upstream, or dewatering of the lake. Installing a plug from downstream would require working around the existing degraded piping, ice plugs would raise concerns of the stresses on the pipes and dewatering was not an option in the short term.

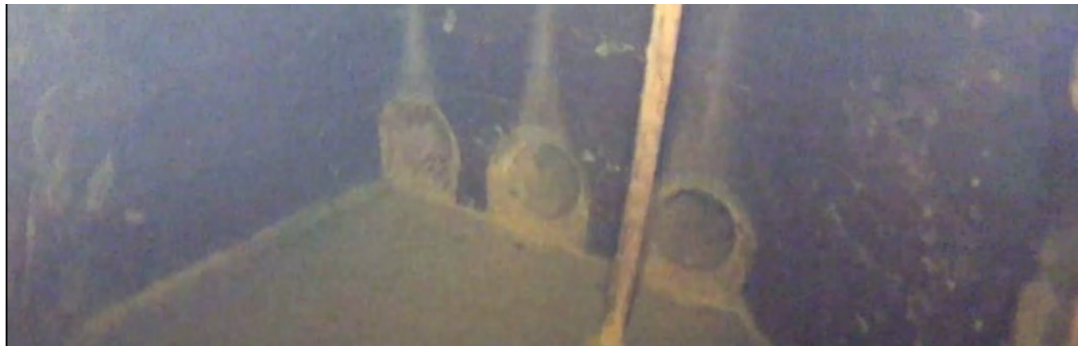
Figure 3-3: Pipes in west outlet from upstream

In the summer of 2023, ASI Marine used divers and ROVs to inspect the upstream face of the east and west bulkhead. Prior to this assessment, the only information about the inlet to each of the discharge pipes was from the 1920s drawings; these drawings had been found to differ from reality in several other locations on the facility.

Based on the information gathered, ASI, in collaboration with Metro Vancouver and KCB, developed a design for plugs that could be inserted into each of these outlets. At the time of writing, these plugs have been designed and will be fabricated and pressure tested in the summer of 2024.

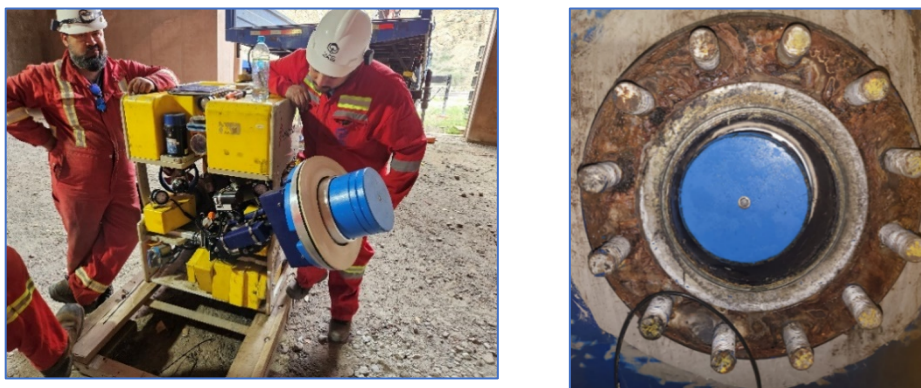
Figure 4-3: ROV fitted with the plug (left) and downstream view of installed plug (right)

Inside the powerhouse was a service water line that was leaking through various valves and a flange. This pipe was a nominal 10-inch (25 cm) offtake from one of the steel penstocks and was operating at full pressure. The owner wanted to decommission the pipe to completely remove the leaking fittings. Unfortunately, there was no means of isolating the pipe from the penstock to remove it. The option to dewater the tunnel was not preferable since this would impose excessive stresses on the tunnel as the pressurized ground water was slowly drawn down during the dewatering process. Since it would take several weeks to dewater the tunnel, there would be a considerable loss of revenue to the project as well. The client issued a request for proposal to see if a remotely operated vehicle (ROV) could be used to plug the pipe from inside the penstock, which would allow them to decommission the piping then isolate and close off the connection point with a blind flange.

The ROV was recovered to surface and fitted with the plug on a manipulator that was part of the machine. This provided some ability to maneuver the plug to the precise orientation needed to seal the opening. Once the system was checked and verified ready to go, personnel once again flew the vehicle down the headrace tunnel to the penstock.

After insertion of the plug, the piping was bled down and removed. The plug provided 100% seal against the face of the penstock, holding back close to 20 tonnes of pressure. A blind flange was then installed to close off the connection point. A small port on the blind flange was used to back-pressure the gap between the plug and flange. This released the plug, allowing the ROV to fly back with the plug, leaving no debris in the penstock that could impact the operation of the turbines. The small port on the flange was closed off and a pipe cap welded over it to ensure full isolation.

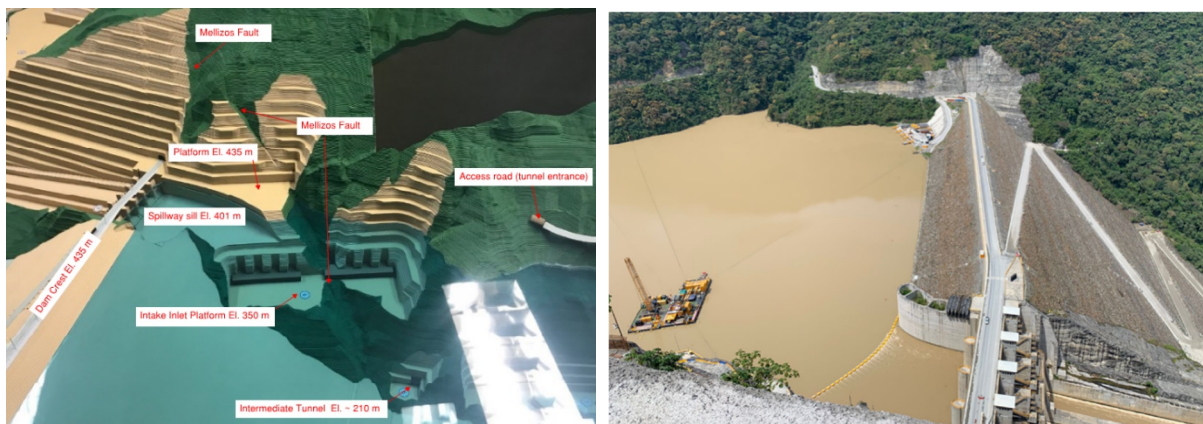
Figure 5-1: The water intakes in relation to other structures

The remediation works to be completed at the low-level outlets, upstream of the intake gates included lining of a 28 m long section of concrete liner, and the removal of two concrete plugs immediately downstream of the inlets. Due to the depth of the intakes (located 60 m below the water level) and the impossibility of draining the reservoir, the remediation works needed to be completed underwater or behind temporary plugs. Also, the repairs would need to be completed near an operating spillway and near operating units. Figure 5-1 illustrates the height of the intake structures in relation to the dam and spillway. Due to the extent of the remediation work, executing the repairs underwater was not possible.
