Volume Thirty One, Issue 6, 2024 CHALLENGES AND ACHIEVEMENTS IN LATIN AMERICA CONCRETE FACED ROCKFILL DAMS - OPTIMIZING BULB UNIT OPERATION - BEARINGS

Underwater applications of prefabricated plugs for maintenance and repairs works at Cheves and Ituango

B. Bagnérès and R. McLachlan, Klohn Crippen Berger (KCB), Canada B. Clarke, ASI Group Ltd - Marine Group, Canada F. Ortiz and R. A. Osorio Tobon, Empresas Publicas de Medellin (EPM), Colombia

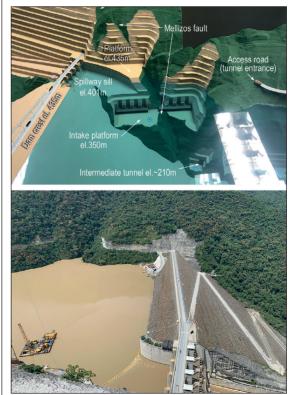
Fig. 3. The Ituango water intakes in relation to the other structures.

operated by Empresas Públicas de Medellín (EPM). The project consists of a 225 m-high earthfill dam and an underground powerhouse on the right bank, adjacent to the dam, and will be equipped with eight ~ 300 MW Francis units with a net head of about 197.6 m and a discharge of 168.8 m³/s per unit. The spillway is adjacent to the right bank, and will have a maximum discharge capacity of 22 137 m³/s controlled by four main 21.5 \times 16.5 m radial gates and a secondary 3 \times 3.9 m radial gate designed to pass the minimum discharge flow. The reservoir extends 75 km upstream, and will provide storage capacity for peak generation. Ituango will be the largest hydro plant in the country and is expected to provide 17 per cent of Colombia's total installed capacity. The water passages leading to the underground powerhouse include intake structures located on the right bank, immediately upstream of the spillway. They comprise eight 6.6 m-diameter inlet tunnels leading to intake gate shafts; the flow is controlled by maintenance and emergency closure gates currently in place. Downstream of the intakes, 135 m high, 6.6 m-diameter steel shafts lead to the generating units in the 240 m long powerhouse cavern.

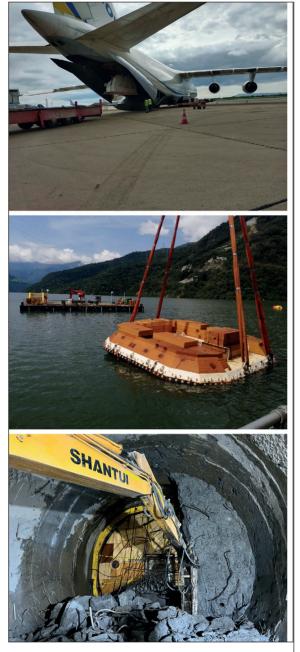
Views of the transportation of the plug in a cargo plane, its immersion at the site, and demolition of the concrete plugs. (Photos by EPM).

The assembly and installation of the plug on site was done using various barges and cranes. Fig. 5 outlines the deployment and installation of the plug with controlled buoyancy by foam bodies installed in the plug, a temporary monorail, carriage, and ROV assistance. Photographs (see next page) were taken by EPM personnel during the transport and installation of the plug.
